# **Metal Fabrication Shop Owner Dies When Crushed By Falling Steel Plate**

**Incident Number: 03KY124**

## **Kentucky Fatality Assessment and Control Evaluation (FACE) Program**

**Subject: Metal Fabrication Shop Owner Dies When  
Crushed by Falling Steel Plate**

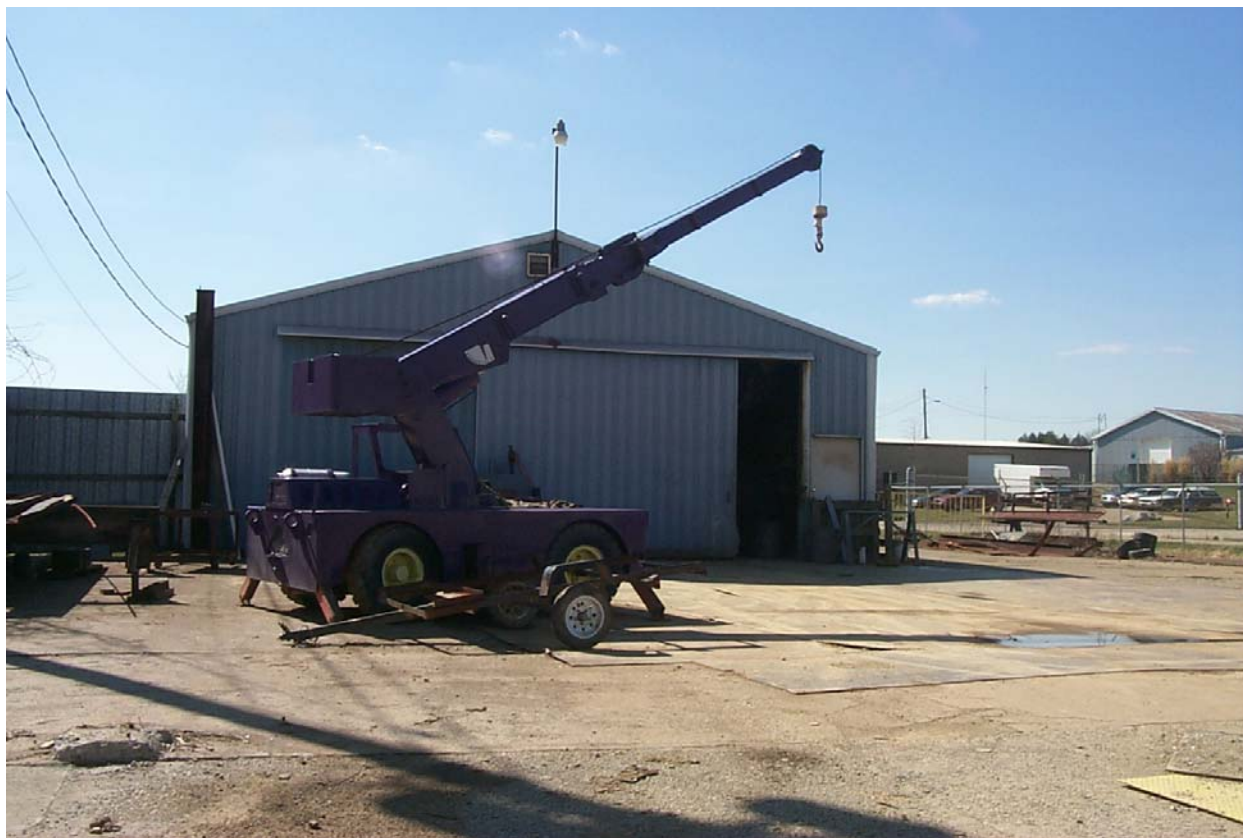
Back of shop where steel plate fell on business owner. The crane was used to load and unload materials.

An adequate beam and hoist mechanism for flipping over large plates and heavy pieces of metal should have been installed. By using a series of clamps and cables attached to an appropriate beam in the ceiling, the cables could be clamped on to the plates and by using tension on the cables, plates could be turned over or moved in a more controlled manner. Another alternative method for turning over cumbersome material would be to use an overhead crane. Either of these methods would allow for a safer way of handling and moving large pieces of steel and turning them over. Metal plates could be hoisted and turned over without positioning blocks underneath the 4,000 pound plate.

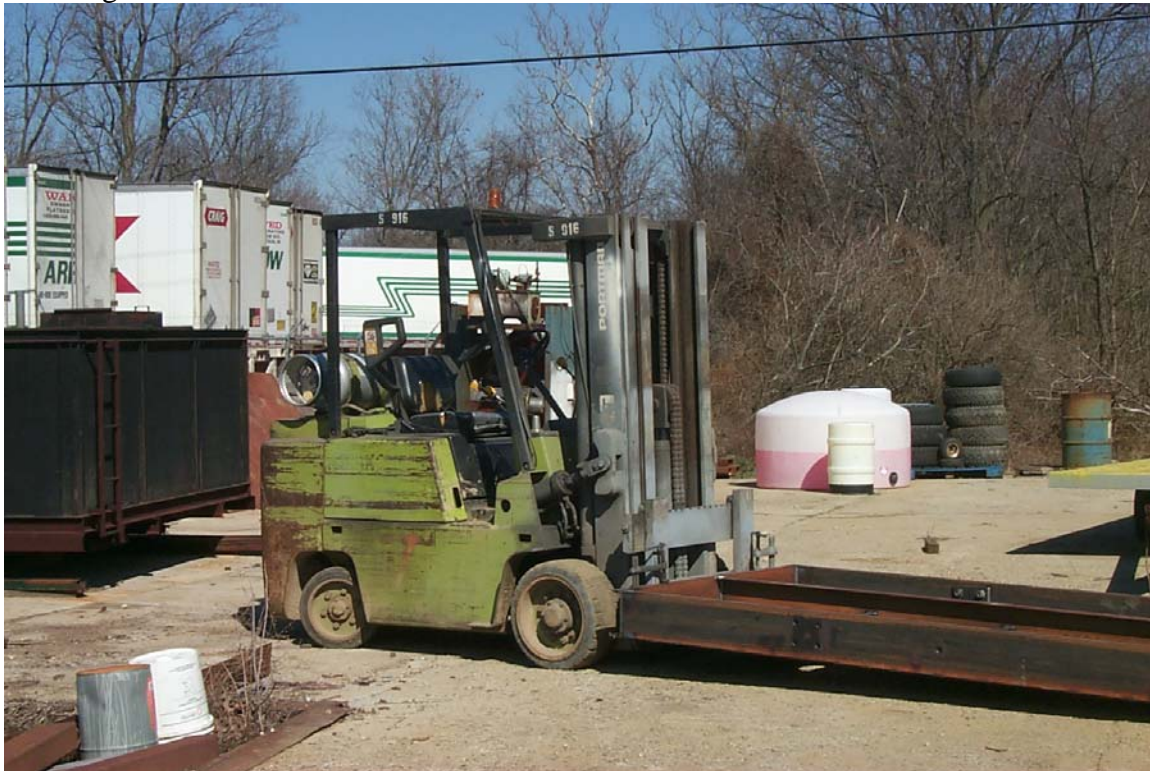
KY OSH 1910.178(o)(1) states, “only stable or safely arranged loads shall be handled. Caution shall be exercised when handling off-center loads which cannot be centered”. Lifting the edge of a 10’ x 20’ metal plate with forks of a forklift is a dangerous undertaking. This type of task, if necessary to perform, should be performed by an individual trained in the mechanics of picking up a typical heavy load such as this with a forklift.

An example of how the fork truck was used to lift the metal plate. This plate is similar to the one that fell on the business owner.
